2024, Part I: PERDIX data transfer

SUB
MARINE
CONSULTING

data transfer
(i.e. the log file)
from PERDIX AI
to a PC
(WIN® 11, i9,
64 GB DDR4)
with the latest
Shearwater® Cloud
via
Bluetooth
(but for local
storage)

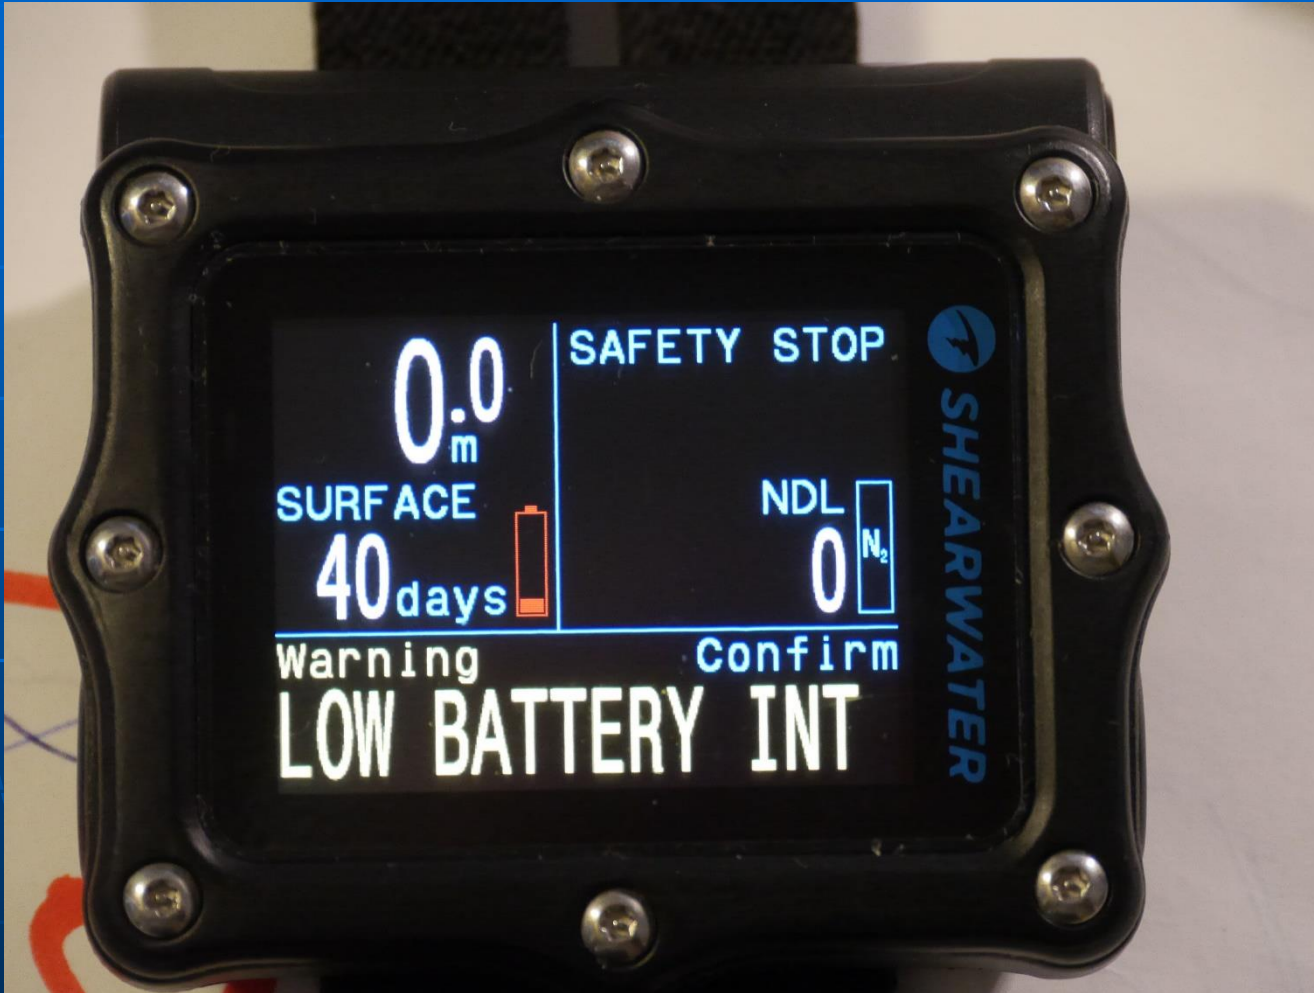
battery replacement helped

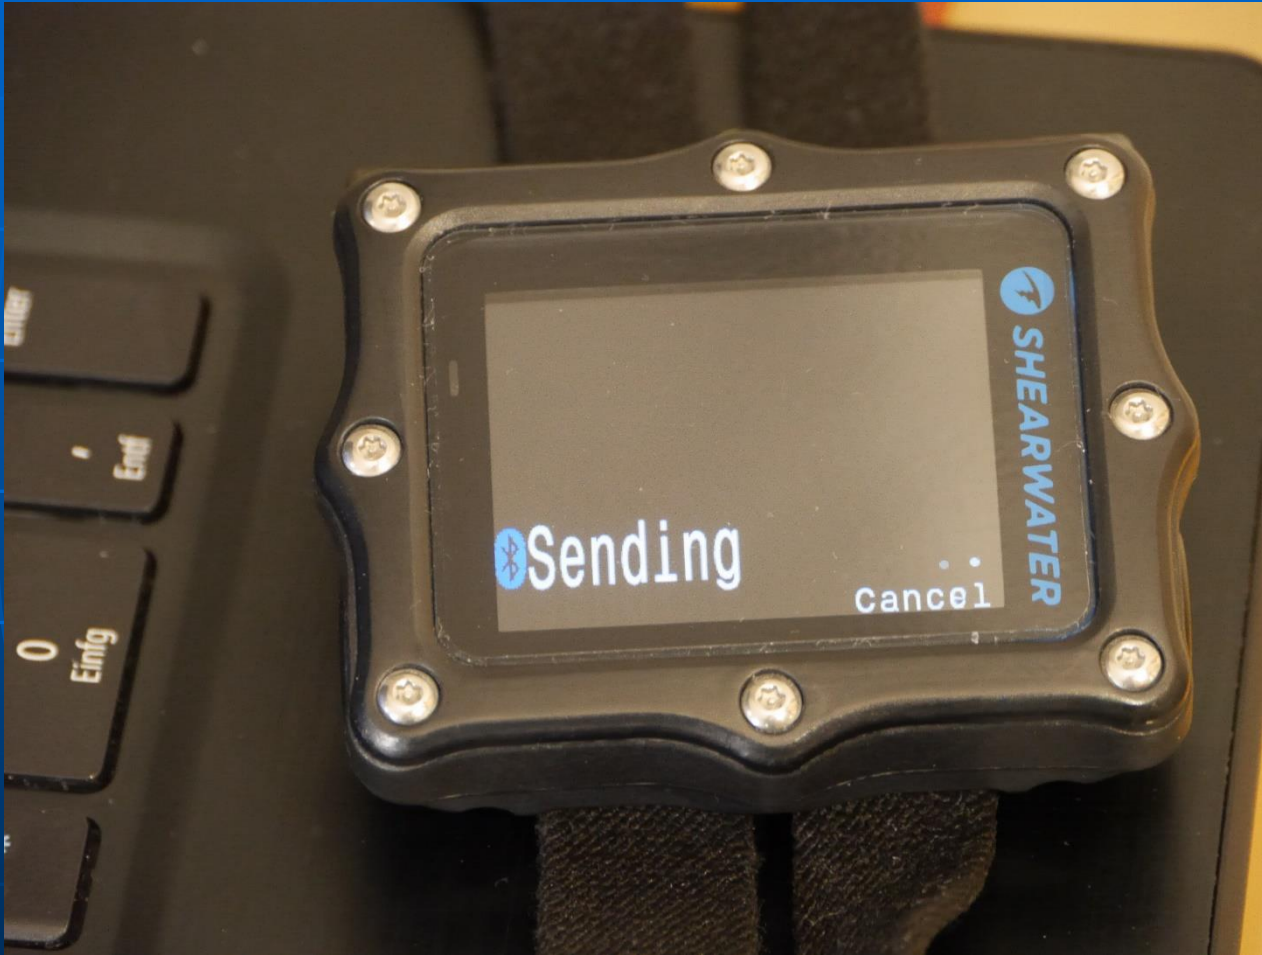
and, finally, connection established

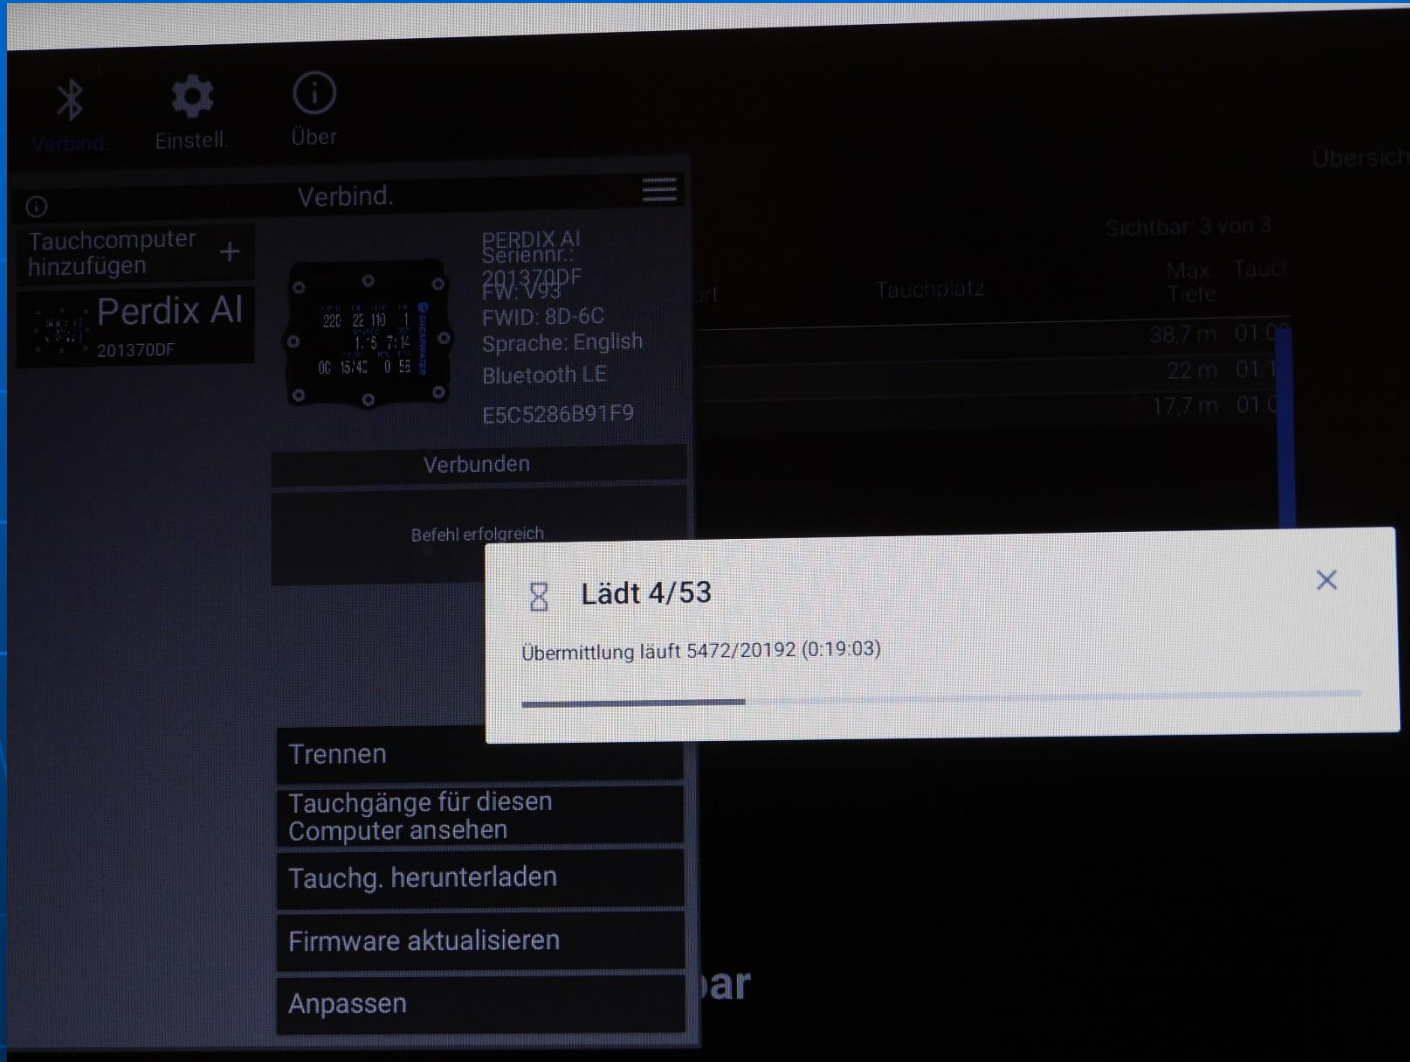
and, then: the data transfer of the log file

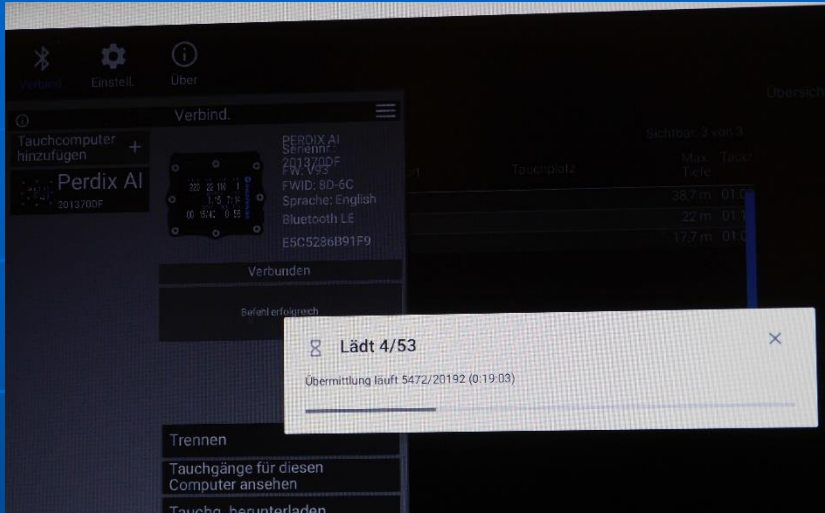
the transfer time for the last ca. 50 dives was ca. 50 min, the transfer time of nearly the same dives from the SCUBAPRO / UWATEC Galileo G2 TEC was *less than 1 (sic: one!) minute* via USB, same PC
