2024, Part I: PERDIX data transfer

SUB
MARINE
CONSULTING

data transfer
(i.e. the log file)
from PERDIX AI
to a PC
(WIN® 11, i9,
64 GB DDR4)
with the latest
Shearwater® Cloud
via
Bluetooth
(but for local
storage)

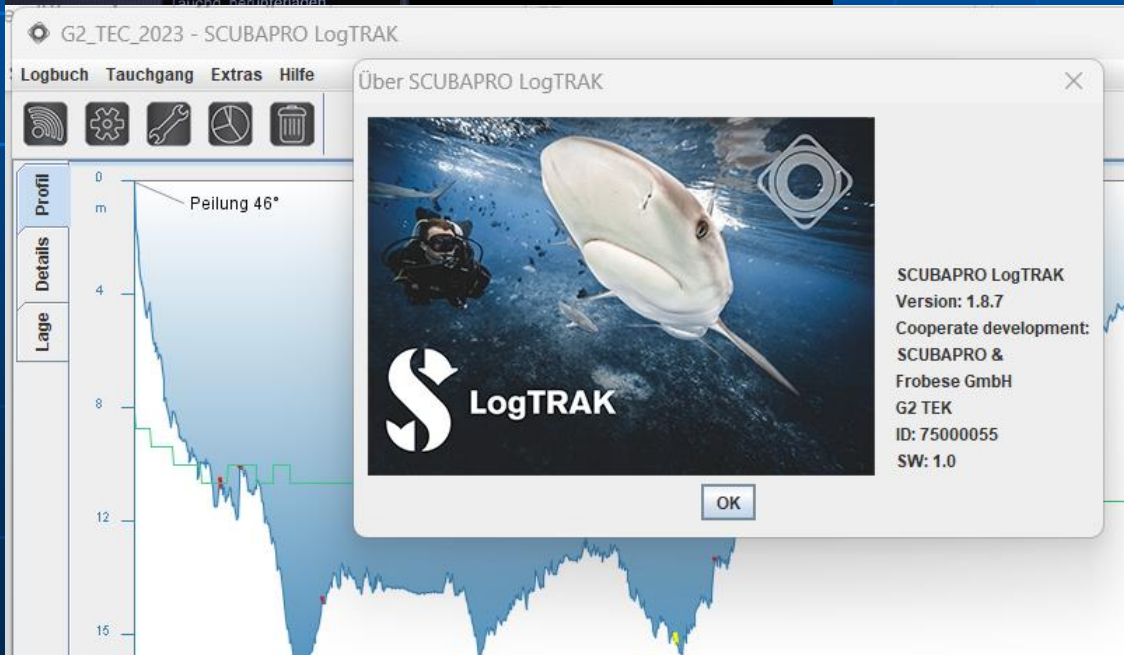
the transfer time for the last ca. 50 dives was ca. 50 min, the transfer time of nearly the same dives from the SCUBAPRO / UWATEC Galileo G2 TEC was *less than 1 (sic: one!) minute* via USB, same PC
